**Flood Control Project Maintenance
Levee Inspections**

Fall 2015 Levee Maintenance Deficiency Summary Report

Reclamation District No. 0755 Randall

Levee Inspection Report By Mile - Fall 2015

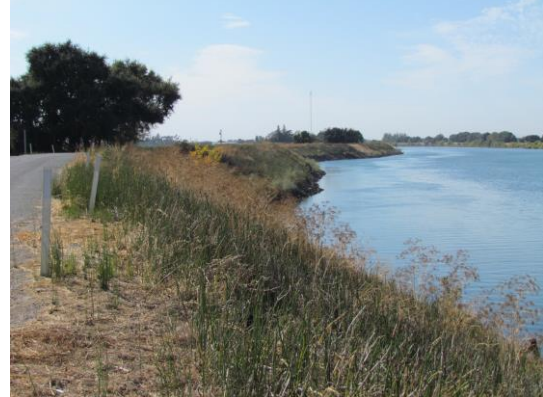
Photo 1 of 1 : FA_2015_RD0755_177_9_20151014_00006.jpg

LM Start	0.17	Rating **	U	Issue No.	9
LM End	1.82	Issue Type +	Ma	Location *	WS
Category	Earthen Levee			GPS Latitude/Longitude	
				Start	End
Item	Vegetation			38.346752 °	38.336687 °
				-121.538672 °	-121.564615 °
DWR ID	DWR_RD0755_01_f_2015_9				
Action/Comments					
Control annual grass and weeds on the levee slopes and easements. Inspector Comments: Remove the unsatisfactory tall weeds from the waterside levee slope.

RD 755 Waterside levee mile 0.17-1.82 levee slope covered with tall weeds such as sweet anise, snap grass and other unsatisfactory weed growth.

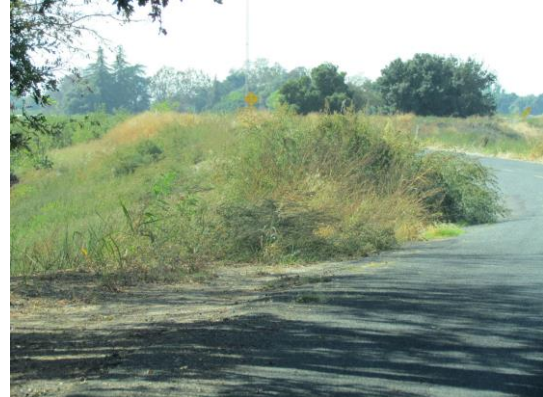
Photo 1 of 1 : FA_2015_RD0755_177_11_20151014_00007.jpg

LM Start	0.26	Rating **	U	Issue No.	11
LM End	0.86	Issue Type +	Ma	Location *	LS
Category	Earthen Levee			GPS Latitude/Longitude	
				Start	End
Item	Vegetation			38.346322 °	38.344352 °
				-121.540168 °	-121.551018 °
DWR ID	DWR_RD0755_01_f_2015_11				
Action/Comments					
Control annual grass and weeds on the levee slopes and easements. Inspector Comments: Remove the tall weeds from the landside levee slope and toe.

Looking downstream landside levee mile 0.26-0.86 slope covered with tall weeds.

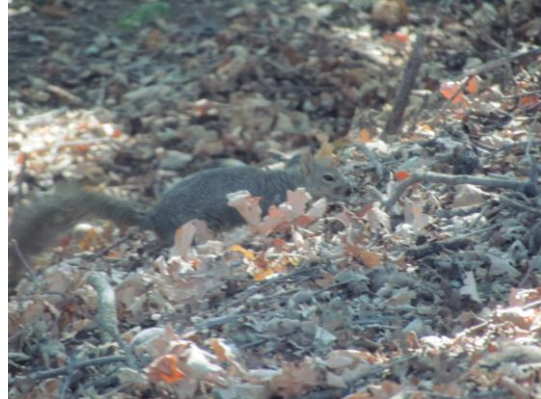
Photo 1 of 1 : FA_2015_RD0755_177_4_20151014_00008.jpg

LM Start	0.43	Rating **	M	Issue No.	4
LM End	1.77	Issue Type +	Ma	Location *	LS
Category	Earthen Levee			GPS Latitude/Longitude	
				Start	End
Item	Animal Control			38.345593 °	38.337197 °
				-121.543263 °	-121.564147 °
DWR ID	DWR_RD0755_01_f_2014_4				
Action/Comments					
Exterminate rodents and backfill and compact or grout burrows. Inspector Comments: There are bait station along the landside levee slope rodents are very active in this location near the walnut trees.

One of many active rodent observed during this inspection.

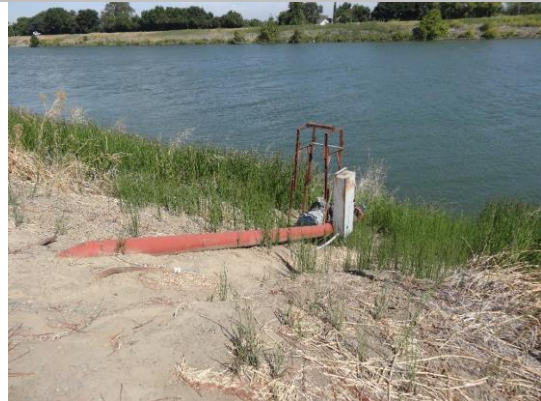
Photo 1 of 3 : UCIP_FA_2015_0522.jpg

LM Start	0.43	Rating **	M	Issue No.	20
LM End	0.43	Issue Type +	En	Location *	LS
Category	Supplemental			GPS Latitude/Longitude	
				Start	End
Item	DWR UCIP Field Study			38.345640 °	38.345640 °
				-121.543277 °	-121.543277 °
DWR ID					
Action/Comments					
Inspector Comments: FS_ID:17123 DS_ID:18849 EP_NO: 4302 FS_HLM: 0.447 Repair Type: Non-Urgent Crossing Status: Found UCIP Comments: FBC about 2 feet.Power conduit also through the leeve.Wet ground on pump site/location. May need investigation about wet ground. FIELD_STRUCT_DESC: 8-inch steel pipe through levee, 2.0 feet below crown. Pump electrical box and control valve on waterward slope. Siphon breaker on landward slope. Service pole at landward toe. (App. No. 4302-Hemly) . FS Date: 08/06/2013

WS view: overview of pump and pipe.

Inspector Comments: FS_ID:17123
 DS_ID:18849
 EP_NO: 4302
 FS_HLM: 0.447
 Repair Type: Non-Urgent
 Crossing Status: Found
 UCIP Comments: FBC about 2 feet. Power conduit also through the levee. Wet ground on pump site/location. May need investigation about wet ground.
 FIELD_STRUCT_DESC: 8-inch steel pipe through levee, 2.0 feet below crown. Pump electrical box and control valve on waterward slope. Siphon breaker on landward slope. Service pole at landward toe. (App. No. 4302-Hemly) .
 FS Date: 08/06/2013

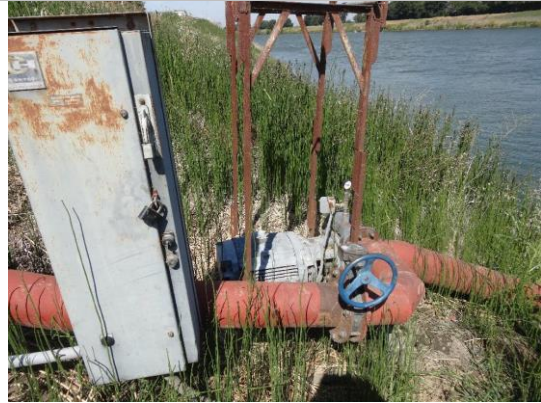
Photo 2 of 3 : UCIP_FA_2015_1393.jpg

WS view: pump, power switch box, butterfly valve and pipe.

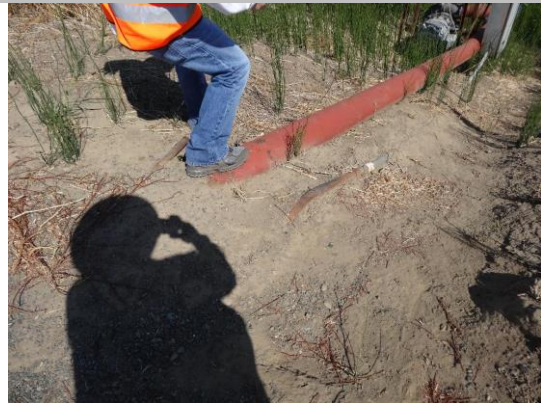
Photo 3 of 3 : UCIP_FA_2015_1394.jpg

WS view: steel pipe and power conduit.

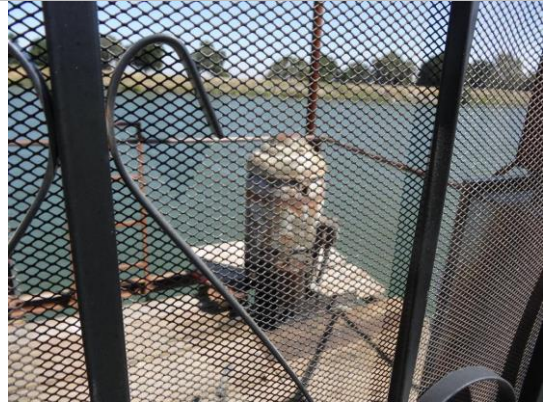
Photo 1 of 3 : UCIP_FA_2015_1126.jpg

LM Start	0.68	Rating **	M	Issue No.	21
LM End	0.68	Issue Type +	En	Location *	LS
Category	Supplemental			GPS Latitude/Longitude	
				Start	End
Item	DWR UCIP Field Study			38.345113 °	38.345113 °
				-121.547789 °	-121.547789 °
DWR ID					
Action/Comments					
Inspector Comments: FS_ID:41634					
DS_ID:18851					
EP_NO: 7357					
FS_HLM: 0.699					
Repair Type: Non-Urgent					
Crossing Status: Found

WS view: pump mounted on pump station/deck.

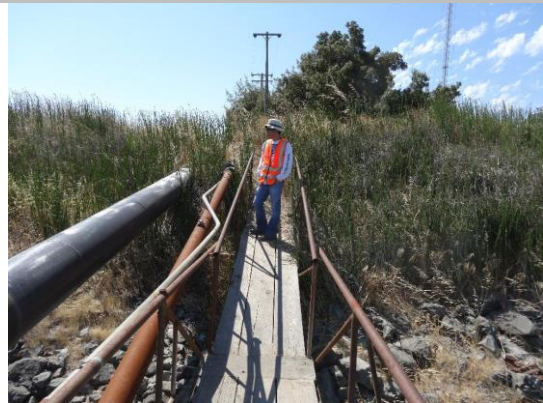
Photo 2 of 3 : UCIP_FA_2015_1146.jpg

WS view: view towards levee crown from pump structure.

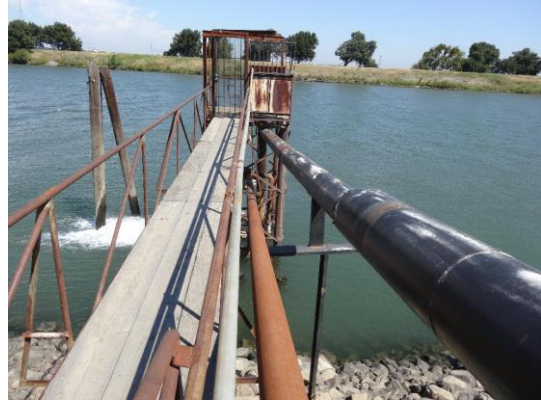
Photo 3 of 3 : UCIP_FA_2015_1147.jpg

LM Start	0.68	Rating **	M	Issue No.	21 (cont)
LM End	0.68	Issue Type +	En	Location *	LS
Category	Supplemental			GPS Latitude/Longitude	
				Start	End
Item	DWR UCIP Field Study			38.345113 °	38.345113 °
				-121.547789 °	-121.547789 °
DWR ID					
Action/Comments					
Inspector Comments: FS_ID:41634					
DS_ID:18851					
EP_NO: 7357					
FS_HLM: 0.699					
Repair Type: Non-Urgent					
Crossing Status: Found

WS view: pump structure on the stream, conduit, pipes, and walkway.

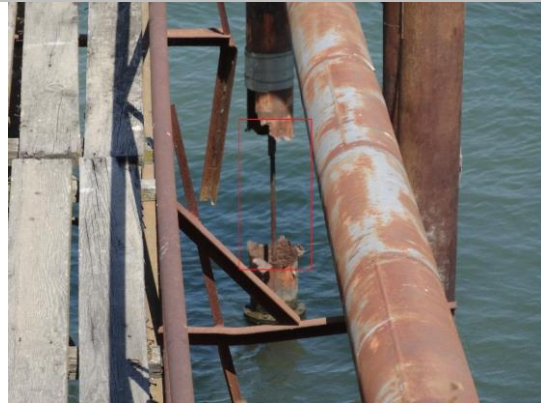
Photo 1 of 3 : UCIP_FA_2015_1301.jpg

LM Start	0.93	Rating **	M	Issue No.	22
LM End	0.93	Issue Type +	En	Location *	LS
Category	Supplemental			GPS Latitude/Longitude	
				Start	End
Item	DWR UCIP Field Study			38.344103 °	38.344103 °
				-121.552119 °	-121.552119 °
DWR ID					
Action/Comments					
Inspector Comments: FS_ID:17063 DS_ID:18855 EP_NO: 11225 FS_HLM: 0.942 Repair Type: Non-Urgent Crossing Status: Found UCIP Comments: Abandoned pipe and pump.Service pole, power box lying on LS slope. FIELD_STRUCT_DESC: Abandoned 10-inch pipe and 1-inch conduit through levee, 5.6 feet below crown, pump on pile structure with walkway to pump. Abandoned service pole on landward slope. (ABO No. 11225- Wilson).O&M Manual Sac 111, May 1959, Revision Year 2011. FS Date: 08/06/2013

WS view: abandoned and discontinued vertical intake pipe

Inspector Comments: FS_ID:17063
 DS_ID:18855
 EP_NO: 11225
 FS_HLM: 0.942
 Repair Type: Non-Urgent
 Crossing Status: Found
 UCIP Comments: Abandoned pipe and pump. Service pole, power box lying on LS slope.
 FIELD_STRUCT_DESC: Abandoned 10-inch pipe and 1-inch conduit through levee, 5.6 feet below crown, pump on pile structure with walkway to pump. Abandoned service pole on landward slope. (ABO No. 11225- Wilson). O&M Manual Sac 111, May 1959, Revision Year 2011.
 FS Date: 08/06/2013

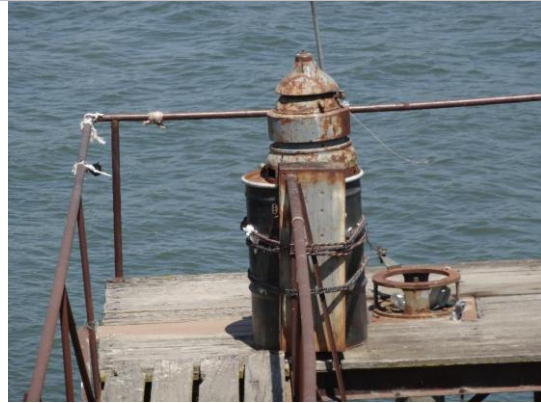
Photo 2 of 3 : UCIP_FA_2015_1302.jpg

WS view: an abandoned pump

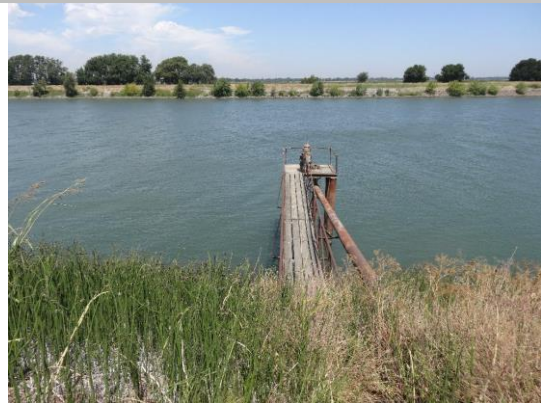
Photo 3 of 3 : UCIP_FA_2015_1303.jpg

WS view: overview of pipe and pump structure.

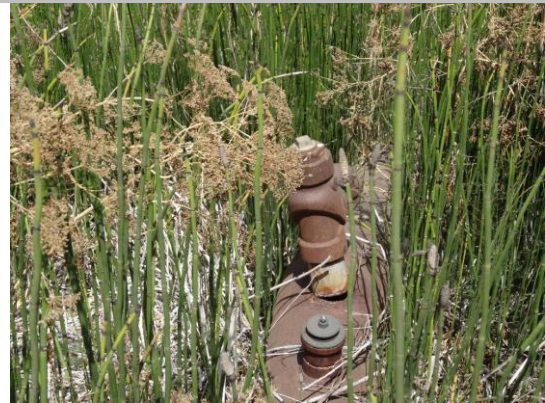
Photo 1 of 2 : UCIP_FA_2015_1304.jpg

LM Start	1.04	Rating **	M	Issue No.	19
LM End	1.04	Issue Type +	En	Location *	LS
Category	Supplemental			GPS Latitude/Longitude	
				Start	End
Item	DWR UCIP Field Study			38.343625 °	38.343625 °
				-121.554145 °	-121.554145 °
DWR ID	DWR_RD0755_01_f_2015_19				
Action/Comments					
Inspector Comments: FS_ID:46764					
DS_ID:18856					
EP_NO: N/A					
FS_HLM: 1.063					
Repair Type: Non-Urgent					
Crossing Status: Found					
UCIP Comments: Needs to be properly abandoned.					
FIELD_STRUCT_DESC: *ABANDONED* 12-inch pipe through levee, 5.0 feet below crown. Siphon breaker on WS, no pipe found on LS. (Cat. IVA-Wilson). O&M Manual Sac 111, May 1959, Revision Year 2011.					
FS Date: 08/06/2013

WS view: steel pipe with siphon breaker on levee slope

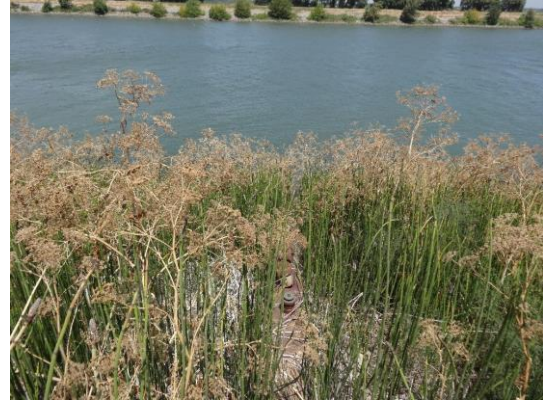
Photo 2 of 2 : UCIP_FA_2015_1305.jpg

LM Start	1.04	Rating **	M	Issue No.	19 (cont)	
LM End	1.04	Issue Type +	En	Location *	LS	
Category	Supplemental			GPS Latitude/Longitude		
				Start	End	
Item	DWR UCIP Field Study			38.343625 °	38.343625 °	
				-121.554145 °	-121.554145 °	
DWR ID	DWR_RD0755_01_f_2015_19					
Action/Comments						
Inspector Comments: FS_ID:46764 DS_ID:18856 EP_NO: N/A FS_HLM: 1.063 Repair Type: Non-Urgent Crossing Status: Found UCIP Comments: Needs to be properly abandoned. FIELD_STRUCT_DESC: *ABANDONED* 12-inch pipe through levee, 5.0 feet below crown. Siphon breaker on WS, no pipe found on LS. (Cat. IVA-Wilson). O&M Manual Sac 111, May 1959, Revision Year 2011. FS Date: 08/06/2013

WS view: overview of steel pipe with siphon breaker on levee slope

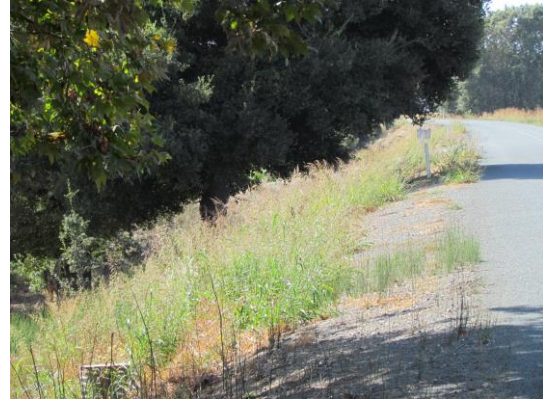
Photo 1 of 1 : FA_2015_RD0755_177_17_20151014_00009.jpg

LM Start	1.11	Rating **	U	Issue No.	17
LM End	1.42	Issue Type +	Ma	Location *	LS
Category	Earthen Levee			GPS Latitude/Longitude	
				Start	End
Item	Vegetation			38.343300 °	38.341243 °
				-121.555373 °	-121.560098 °
DWR ID	DWR_RD0755_01_f_2015_17				
Action/Comments					
Control annual grass and weeds on the levee slopes and easements. Inspector Comments: Remove the tall weeds from the levee slope.

Unsatisfactory tall weed growth on the landside levee slope.

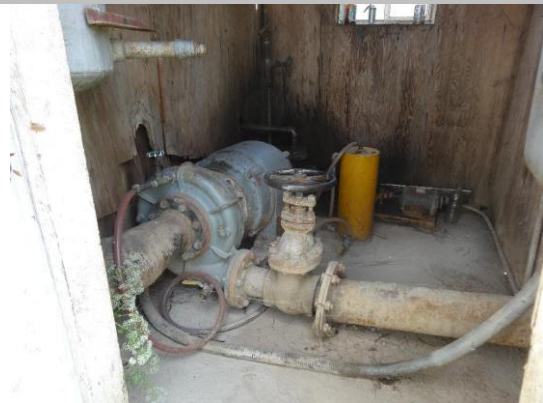
Photo 1 of 3 : UCIP_FA_2015_0526.jpg

LM Start	1.12	Rating **	M	Issue No.	23
LM End	1.12	Issue Type +	En	Location *	LS
Category	Supplemental			GPS Latitude/Longitude	
				Start	End
Item	DWR UCIP Field Study			38.343305 °	38.343305 °
				-121.555538 °	-121.555538 °
DWR ID					
Action/Comments					
Inspector Comments: FS_ID:17144					
DS_ID:18857					
EP_NO: 11219					
FS_HLM: 1.142					
Repair Type: Non-Urgent					
Crossing Status: Found					
UCIP Comments: - requires cleaning of siphon breaker box.					
FIELD_STRUCT_DESC: 8-inch pipe through levee, 5.7 feet below crown. Siphon breaker inside CM Pipe riser on landside shoulder. Power pole on landside. Pump and power box in pump house on waterward slope. (ABO No. 11219- Elliott). O&M Manual Sac 111, May 1959, Revision Year 2011.					
FS Date: 08/06/2013

WS view: pumps, butterfly valve and pipe inside pump house.

Inspector Comments: FS_ID:17144
 DS_ID:18857
 EP_NO: 11219
 FS_HLM: 1.142
 Repair Type: Non-Urgent
 Crossing Status: Found
 UCIP Comments: - requires cleaning of siphon breaker box.
 FIELD_STRUCT_DESC: 8-inch pipe through levee, 5.7 feet below crown. Siphon breaker inside CM Pipe riser on landside shoulder. Power pole on landside. Pump and power box in pump house on waterward slope. (ABO No. 11219- Elliott). O&M Manual Sac 111, May 1959, Revision Year 2011.
 FS Date: 08/06/2013

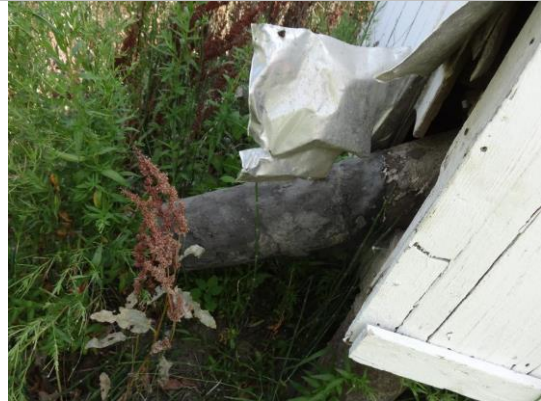
Photo 2 of 3 : UCIP_FA_2015_0527.jpg

WS view: pipe daylight from pump house.

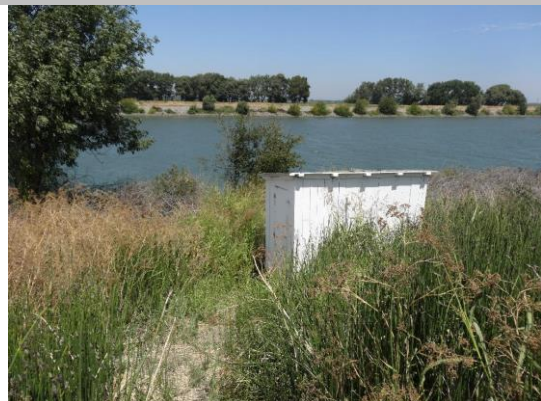
Photo 3 of 3 : UCIP_FA_2015_0528.jpg

WS view: pump house on levee slope.

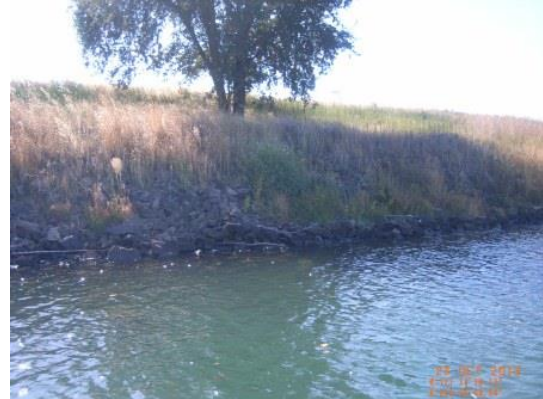
Photo 1 of 1 : USACE2013A_SAC_35-4_L_7.jpg

LM Start	1.24	Rating **	M	Issue No.	1
LM End	1.32	Issue Type +	Ma	Location *	WS
Category	Supplemental			GPS Latitude/Longitude	
				Start	End
Item	2015 USACE Erosion Survey, DRAFT			38.343071 °	38.342426 °
				-121.557706 °	-121.559163 °
DWR ID					
Action/Comments					
Inspector Comments: 2003 - Toe and lower slope eroding, rock in water and a few pieces on the slope; rock at upstream and downstream ends. 2005 - Looks a little worse. Two major holes with vertical banks and smaller intermittent pockets in between. Stone is present upstream, downstream, and at toe. 2008 - Repaired at both ends (50 ft of new stone) but middle remains unrepaired. 2011 - Site extended

USACE 2013 Photo #1

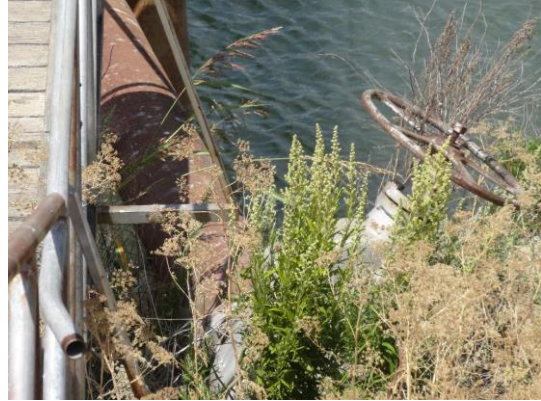
Photo 1 of 3 : UCIP_FA_2015_0523.jpg

Inspector Comments: FS_ID:17143
 DS_ID:18858
 EP_NO: 11219
 FS_HLM: 1.6615
 Repair Type: Non-Urgent
 Crossing Status: Found
 UCIP Comments: - Pump and walkway seem abandoned.- Power line is not connected with pump.- A pump house like structure found on LS levee toe.
 FIELD_STRUCT_DESC: 16-inch pipe through levee, 8.5 feet below crown. Pump on pile structure in stream. Walkway to pump. Siphon breaker and power pole on landward slope. (ABO No. 11219-Elliott).
 O&M Manual Sac 111, May 1959, Revision Year 2011.
 FS Date: 08/06/2013

WS view: Pipe and butterfly/gate valve on levee slope.

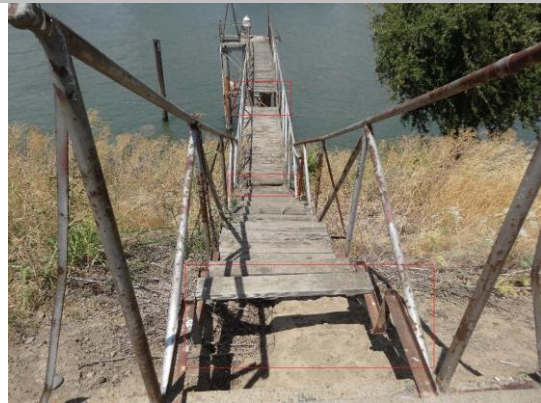
Photo 2 of 3 : UCIP_FA_2015_0524.jpg

WS view: Abandoned walkway and pump structure

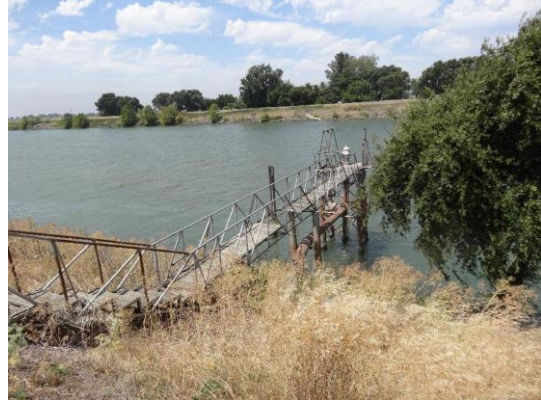
Photo 3 of 3 : UCIP_FA_2015_0525.jpg

WS view: Overview of walkway, pump structure, and pipe.
